SEAWALL AND REVETMENT EFFECTIVENESS, COST AND CONSTRUCTION

by COURTLAND A. COLLIER

REPORT NUMBER 6

MAY 1975

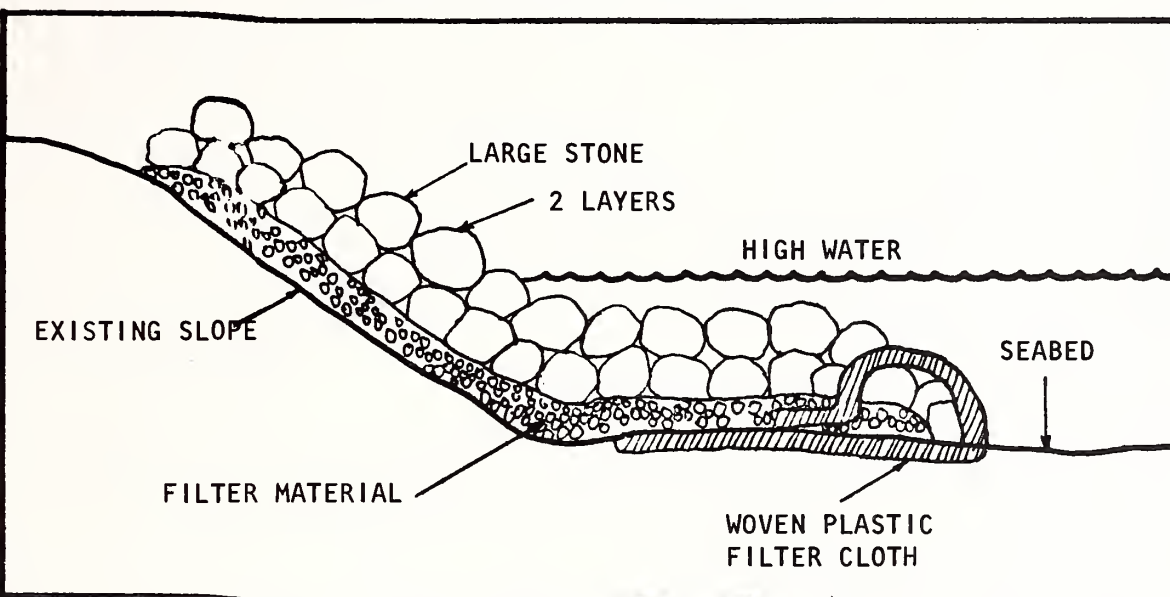
Rule 1
USE MATERIAL THAT IS HEAVY AND DENSE
ENOUGH THAT WAVES WILL NOT MOVE
INDIVIDUAL PIECES OF THE PROTECTION.

Fig. 30. Heavy dense units needed (Ref. 10)

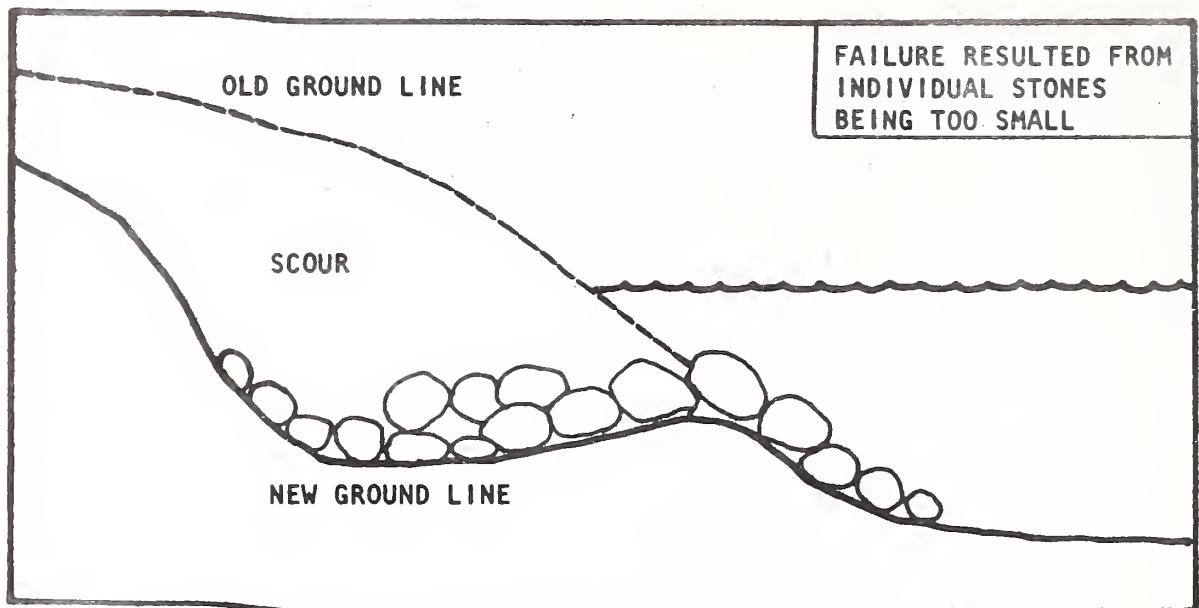
CHECK FOR SIGNS OF FAILURE. A cause of common failure is to use undersized material; waves have tremendous power and can move a lot of material in a short time. Small stones, or pieces of concrete, will be moved around and carried away by small waves. Larger waves will do it even faster. The bank revetment shown in Fig. 31 was constructed of undersized stone that was carried down the slope by large waves. Excessive settlement, increase in voids, loss of filter material, erosion behind, or at the end of the structure can result due to the use of small stone; a layer or two of filter material may be required between underlying ground and the protective material.

Fig. 31. Failure due to too small units (Ref. 10)

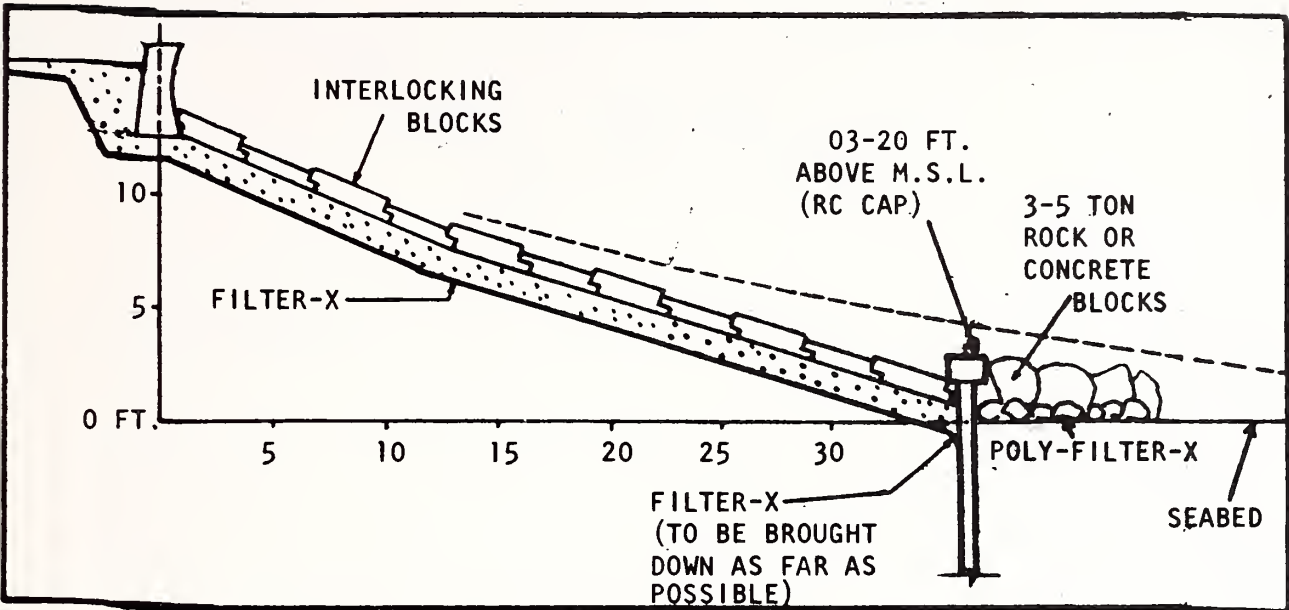
BUILD REVETMENT HIGH ENOUGH THAT WAVES CANNOT OVERTOP IT (SPRAY OVERTOPPING IS ALL RIGHT, BUT NOT "GREEN" WATER)

Fig. 32. Prevent serious overtopping (Ref. 10)

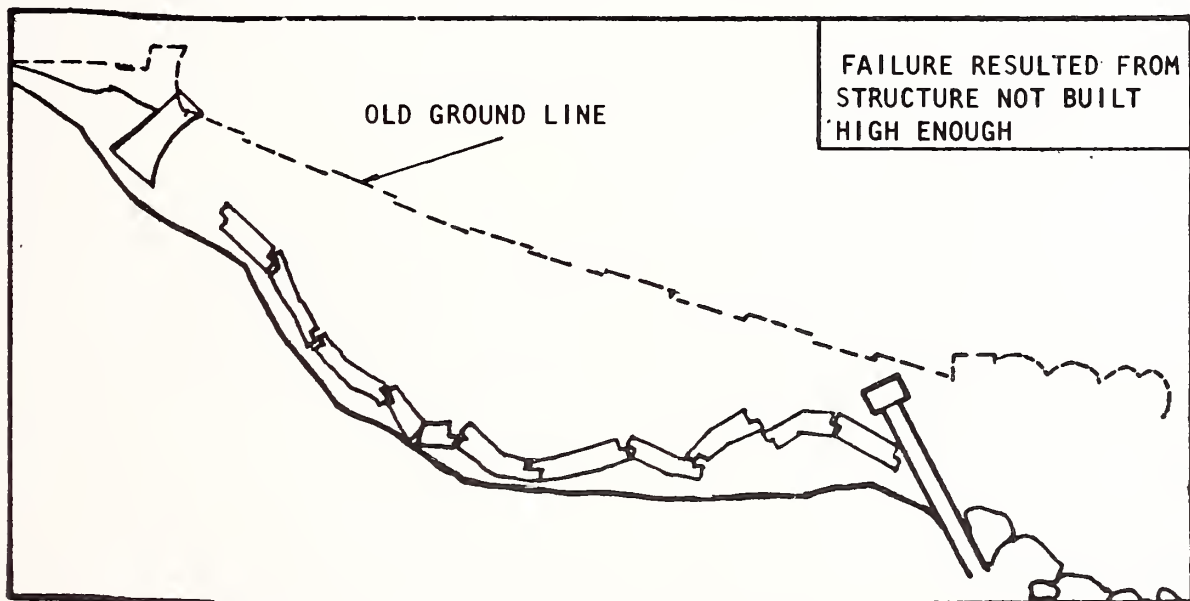
Many failures have happened because the structure was not built high enough and erosion could then continue behind the structure as if it were not there. Check for depressed or broken blocks, excessive movement, and erosion behind or at ends of structure.

Fig. 33. Revetment failure (Ref. 10)

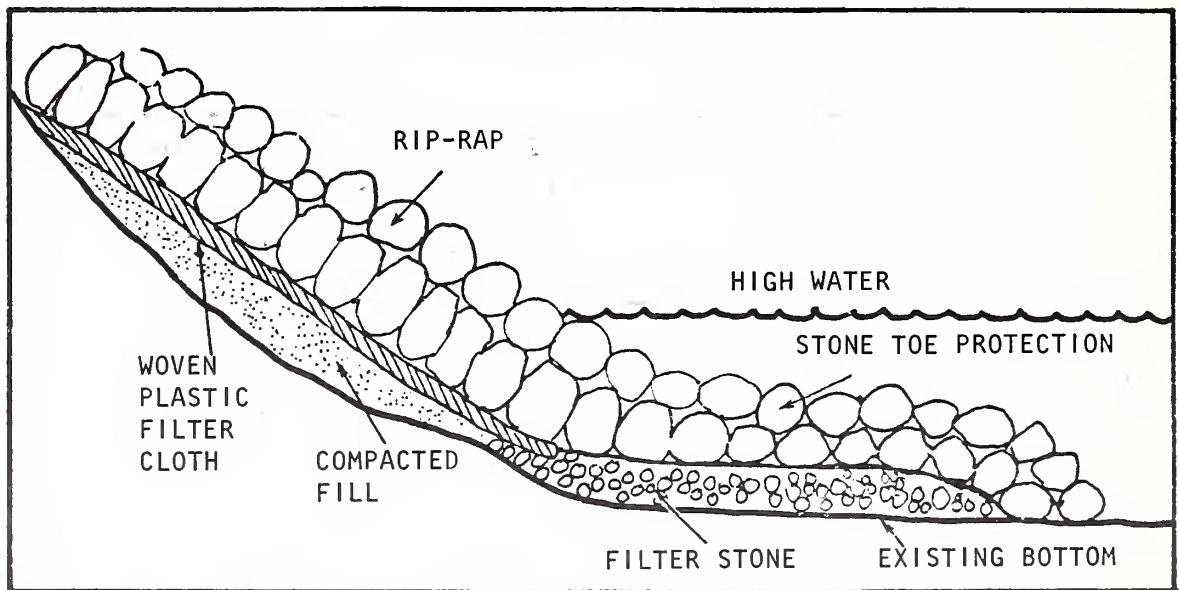
MAKE SURE THAT VOIDS BETWEEN INDIVIDUAL
PIECES OF PROTECTION MATERIAL ARE
SMALL ENOUGH THAT UNDERLYING MATERIAL
IS NOT WASHED OUT BY WAVES.

Fig. 34 Prevent loss of supporting material (Ref. 10)

A filter material such as woven plastic filter cloth must be placed on a highly erodible embankment to prevent the fine materials from washing through the voids in the structure. The protection material must be thick enough to make a long passage for dissipation of wave energy prior to reaching the underlying materials. As seen in Fig. 35, woven plastic filter cloth was not included. As a result fine material was washed out by waves.

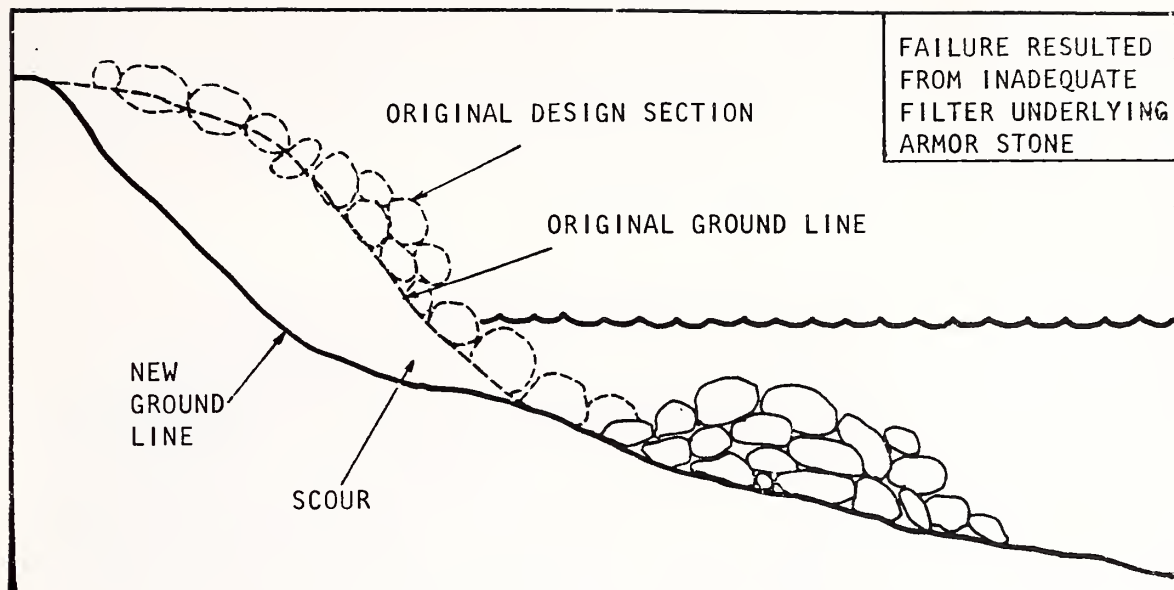
Fig. 35. Failure due to loss of supporting material (Ref.10)

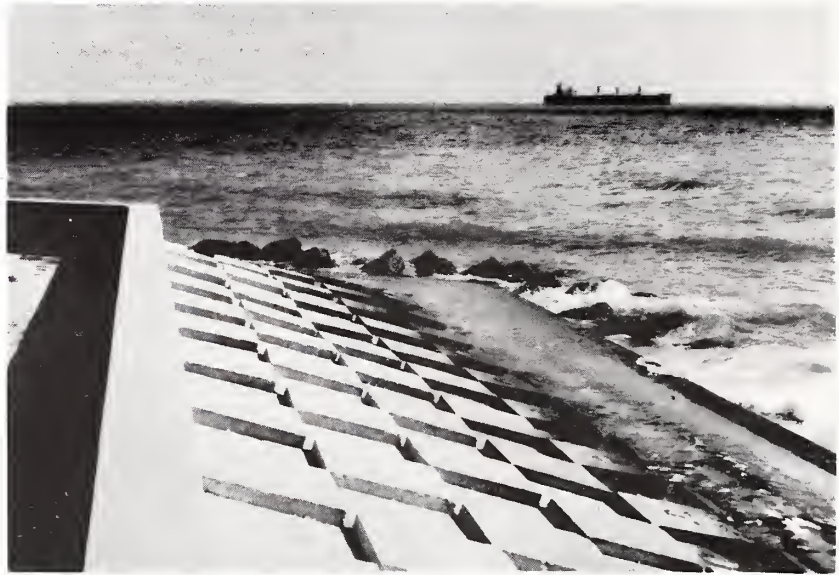
On Florida's gulf coast the sloped checkerboard revetment has been quite successful when properly installed. Pictured after 10 years of use is the revetment at the south west tip of Mullet Key, constructed in 1964 (Fig. 36). The installation consists of a deep toe wall, headwall with a slight reentrant curve, and plastic filter mats overlain with gravel and topped with precast interlocking checkerboard squares.

Fig. 36. Interlocking concrete block revetment ,
constructed in 1964

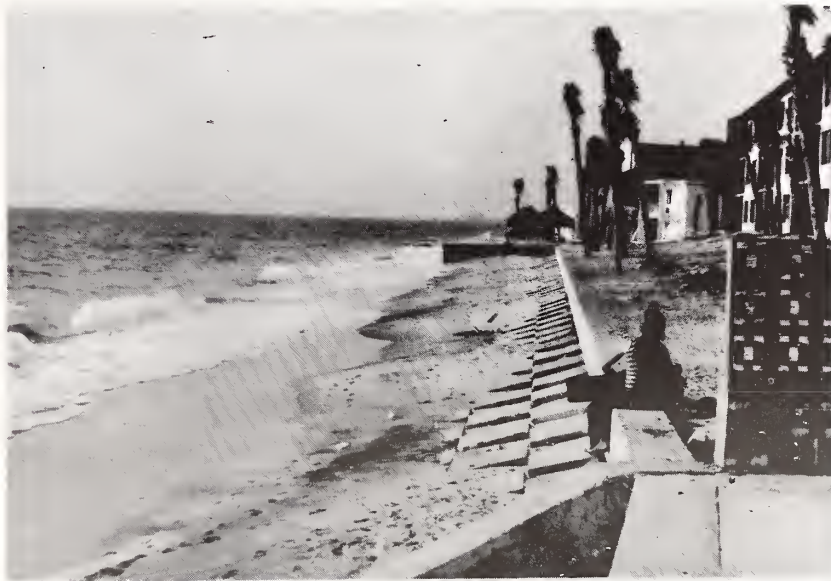
Along the eastern shore of Clearwater Harbor is a smaller sloped checkerboard revetment protecting a multi-unit residential complex (Fig. 37). This also has a toe wall which is largely covered with beach sand even though the installation is less than a year old. This revetment allows much easier access to the beach and water than does a vertical wall. The cost was approximately \$300 lineal foot.

Fig. 37. Concrete block revetment partially covered with beach

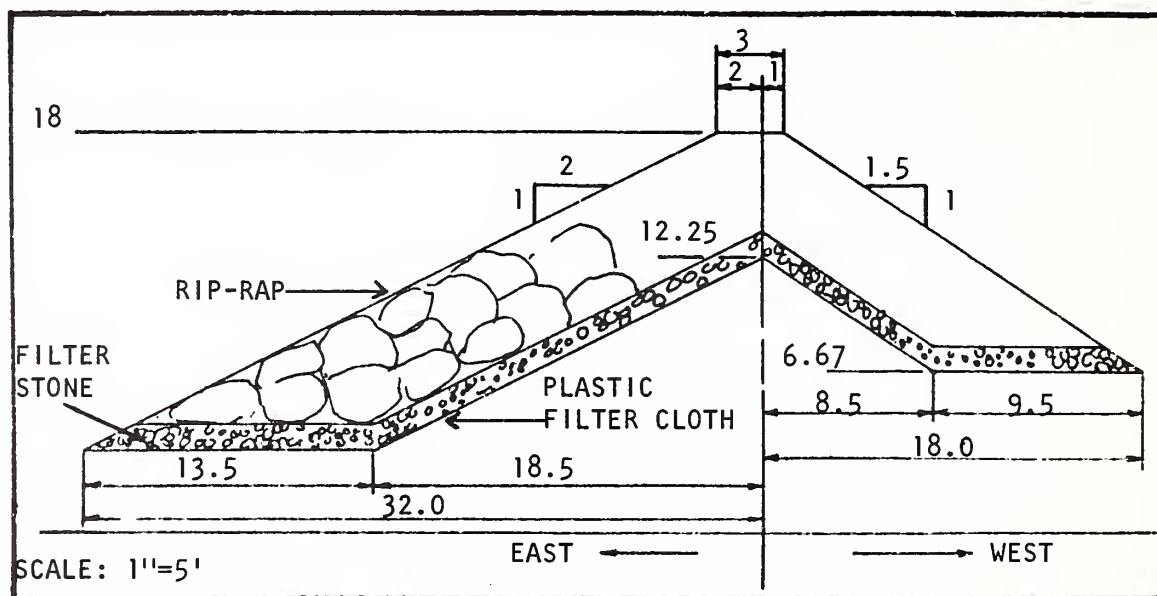
A revetment constructed during summer 1974 at Sebastian Inlet as a protection for the McLarty State Museum is shown in Fig. 38. The underlying material is ordinary white beach sand common to the area. It was shaped to the profile shown under the filter stone. Sheets of green plastic filter cloth were then laid over the sand and pegged into place with steel pegs. A bedding layer of small filter stone was placed over the cloth to a thickness of one foot. Large boulders were then placed by crane to a depth of about 5 feet and the whole area covered over with sand. The boulders cost about \$25 per ton in place (Ref. 9).

Fig. 38. Revetment protecting McLarty State Museum

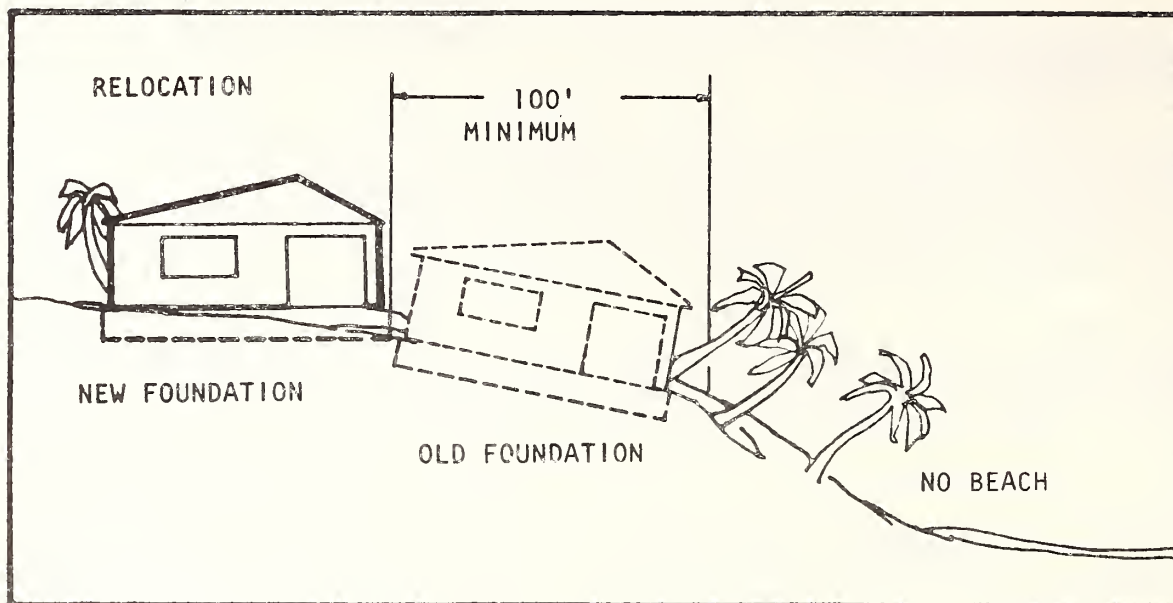
Fig. 43. Saving a Structure by Relocation

This alternative provides for the permanent relocation of homes subject to destruction by erosion induced foundation failure. Relocation is accomplished by home movers. The important planning consideration is the rate of erosion. Key design considerations are the condition of the home, foundation and utilities, access and obstructions, length of move, new foundation and utilities.

Threatened structures may be relocated behind a natural defensive system if there is a suitable site available and a house-moving contractor is able to move the structure (Fig. 43). Shore systems often may be balanced by providing replenishment of the dune and vegetation system. Detailed design information on dune stabilization and enhancement is available in a Sea Grant report entitled Protection and Restoration of Beaches and Dunes Using Vegetation.

The average cost of moving a typical home is about \$8,000, excluding the cost of land. This cost includes house moving (\$3,500), new foundation (\$3,500), and utilities and service (\$1,000). The cost of a new lot varies considerably depending on location.

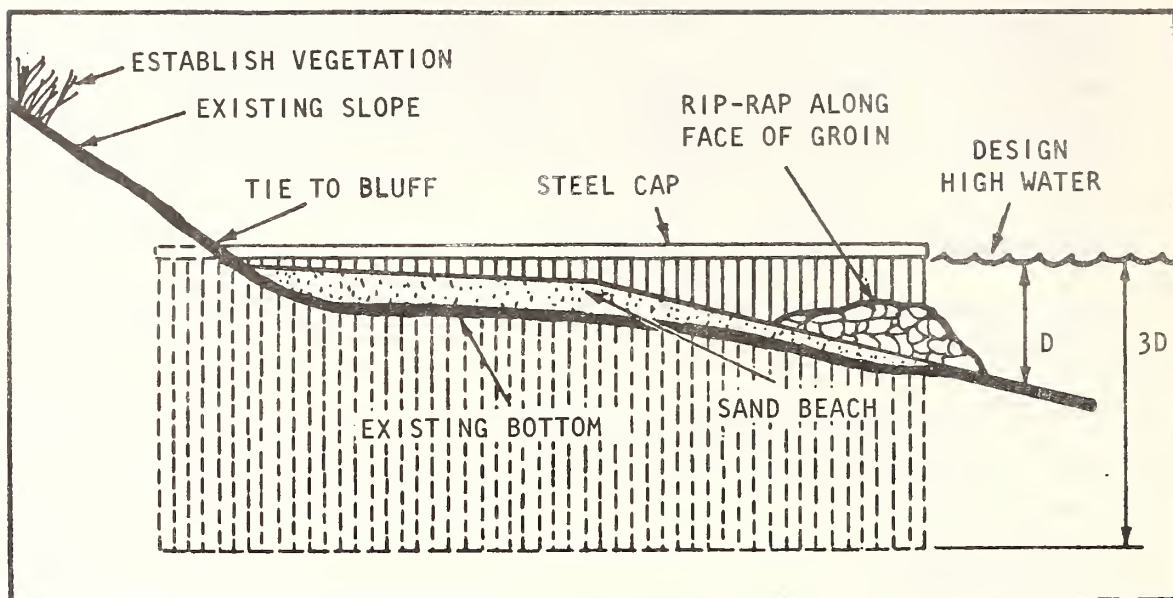
Fig. 44. Impermeable Groin

Protection of the shoreline by groins assumes sand is available and is moving along the shoreline. Groins can have the undesirable effect of damaging downdrift shores. The layout of groins is very important. Groins should be kept low, only one foot above the expected high water, and short, terminating at the 3 foot depth. Groins must be protected from flanking by tying them well into the bank. The maximum length of groins should not exceed 100 feet. If possible groins should be artificially nourished by placing sand on the updrift side of each groin.

Groins may be used to either maintain a beach with its present profile by deflecting or dissipating erosive currents and waves or build up a beach by trapping littoral sand passing along in the shallows seaward of the beach. Groins consist of low barrier walls extending seaward and, while usually intended to protect the shore, may often lead to shore erosion if not properly designed, installed, and maintained. If the upstream side of the groin is not filled with sand at the time of construction, a part of the natural littoral flow of sand along the coastline is usually intercepted by the groin and retained on the upstream side. The usual result is a build-up of sand on the upstream side with a consequent erosion on the downstream side. If the groin is too long, the sand carried around the end of the groin tends to become lost in deep water rather than provide nourishment for downstream beach areas (Ref. 4, pg. 221). See figures 44 and 45.

COST/LIN. FT. - \$80/ LF for 100' LOT

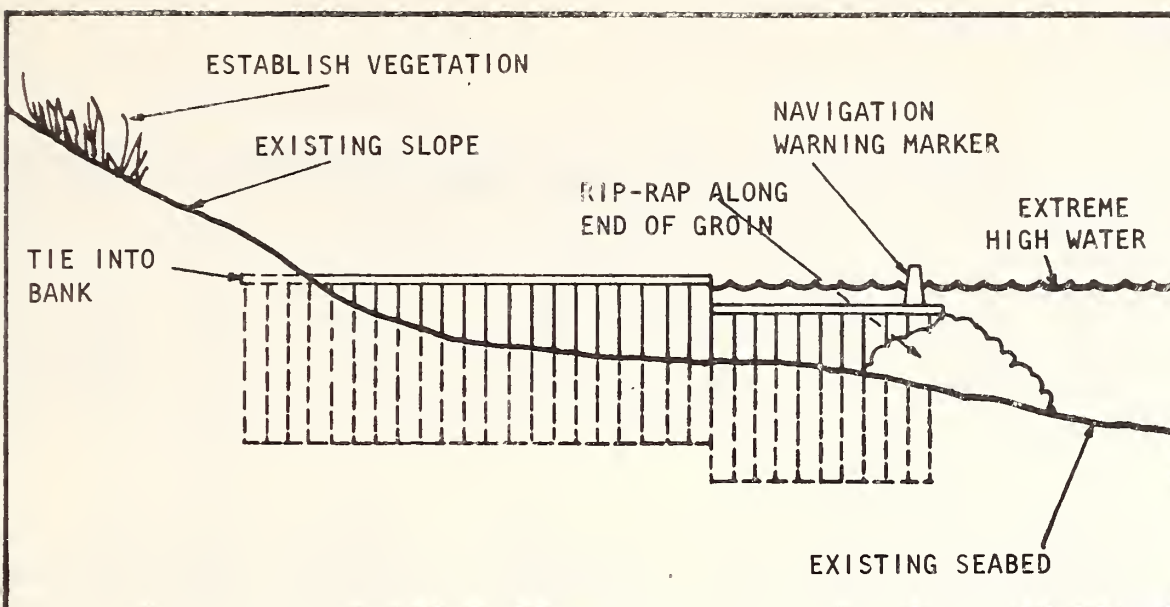
Caution. Groins are shore protection structures that interfere with shore processes and entrap beach materials. Their use demands extreme caution to preclude major downdrift erosion. Consider them only in areas of substantial sand movement. Make them low so they will be overtopped by waves during storms. Groins should be constructed in stages, starting at the extreme downdrift end of the area to be protected. Study the effects of the single groin carefully before completing the layout of the groin field.

Fig. 45. Step down groin

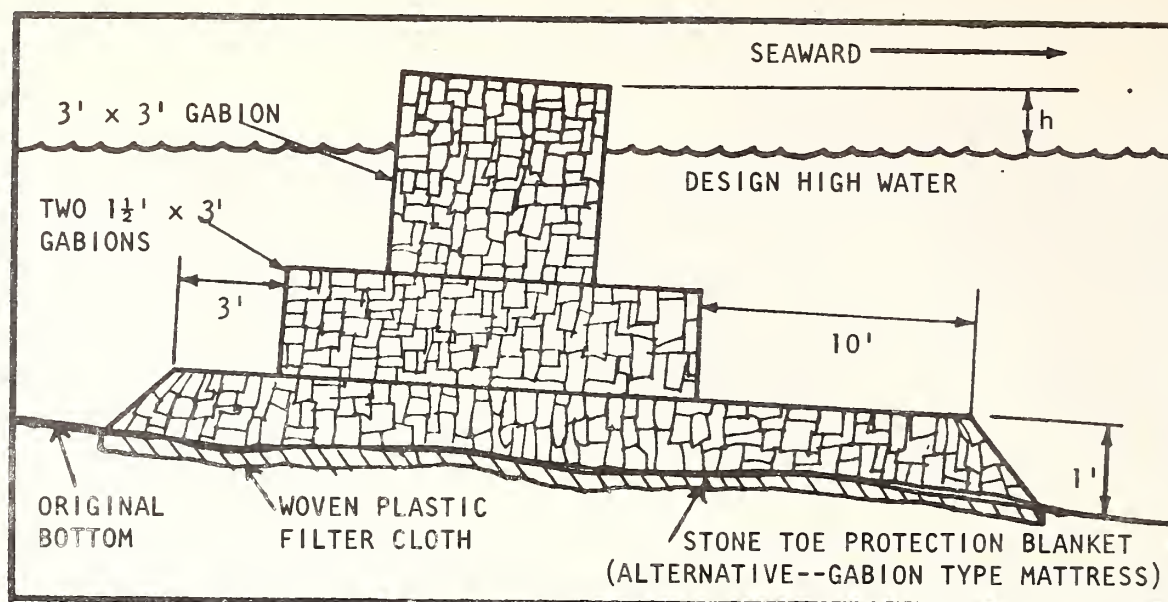
Fig. 46. Offshore Breakwater

Offshore breakwaters are an acceptable method of shore protection for flat or moderate offshore slopes. The design wave is based on water depth 50 feet seaward of the structure.

- (1) gabions consisting of stone filled cages of 71 cubic feet capacity slung into position during low tide, ranging in elevation from 2 ft. below LWL to 1 ft. above HWL, involving an overall height of 13 ft. (Fig. 46).
- (2) rip-rap constructed in the dry by overfilling the area, then excavating and dewatering. The dimensions are approximately the same as the gabions.

It was estimated the gabions cost about 50% as much as an equivalent revetment wall, while the rip-rap cost about 75% as much as the revetment. The rip-rap was preferred finally because of the rising price of PVC coated steel used in the gabions, and the problem of damage to the gabions caused by people searching for shellfish taking refuge inside the gabions (Ref. 4, page 307).
